Chapter DHS 163

APPENDIX G

Conducting a Visual Inspection

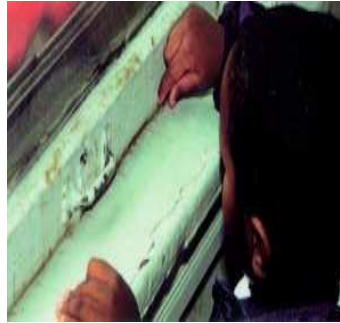
b. Mildew. A potential hazard is the formation of microbial growth on a painted surface. It is usually caused by excessive moisture. Mildew should be removed as a preventive measure to decrease the chance of paint film deterioration.

Paint affected by the mildew is deteriorated paint and must be repaired when an adhesion test determines that any layer is not securely bonded. To conduct an adhesion test, firmly press a 2" x 2" piece of masking tape to the suspect paint and rub the tape to adhere firmly. Lift up on one corner of the tape and remove the tape. If paint is evident on the tape, the paint is separating from the substrate or from underlying paint, and is not securely bonded.

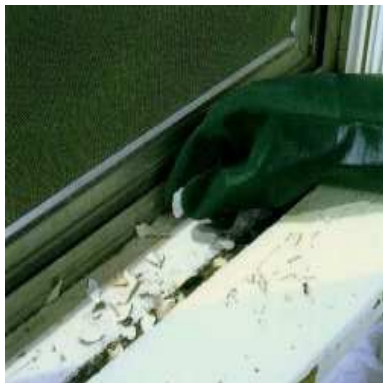
d. **Paint Chips and Other Paint Debris.** The presence of paint chips and debris that have not been proven to be lead-free are considered a hazard. They are evidence that paint is either deteriorated or subject to friction or impact. Visually inspect the floor, stairs, window wells/troughs and sills, and dripline for the presence of paint chips or other paint debris.

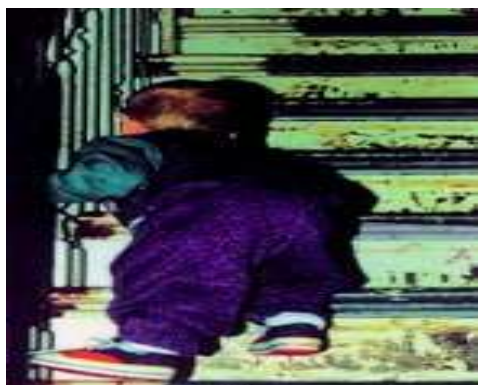
e. **Painted Friction or Impact Surface.** The friction and impact surfaces are evidenced by worn or chipped paint. The friction and impact of these surfaces can also result in dust-lead, which is not detected in a visual inspection.

Worn paint is often due to improperly hung doors, sticky window sashes, sticky drawers, etc. A source of dust-lead are windows that do not operate smoothly and doors that bind or otherwise contact the frame. To test for friction surfaces open and close painted doors, drawers and windows. Visually inspect doors, windows, trim, floors and stairs for evidence that the paint is worn or chipped.

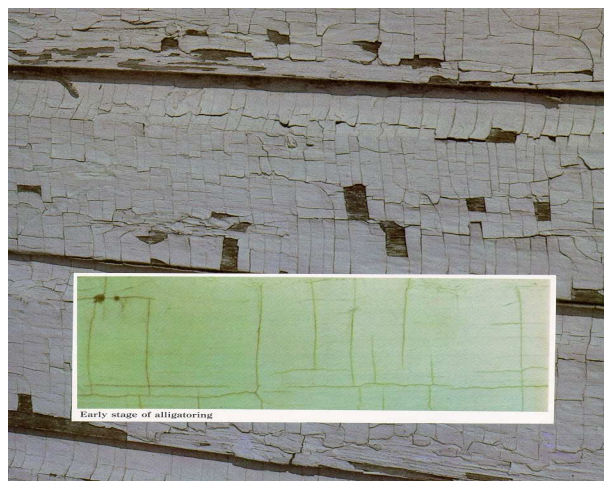
a. **Alligating Paint.** Alligating can be identified by reptilian scale patterns on dried paint films. It is often caused by the inability of the topcoat to bond smoothly to a glossy coat underneath. Alligating is usually associated with paint films that are too thick, or the application of a brittle coating over a more flexible one.

Alligating paint is deteriorated paint and must be repaired when an adhesion test determines that any layer is not securely bonded. To conduct an adhesion test, firmly press a 2" x 2" piece of masking tape to the suspect paint and rub

the tape to adhere firmly. Lift up on one corner of the tape and remove the tape. If paint is evident on the tape, the paint is separating from the substrate or from underlying paint, and is not securely bonded.

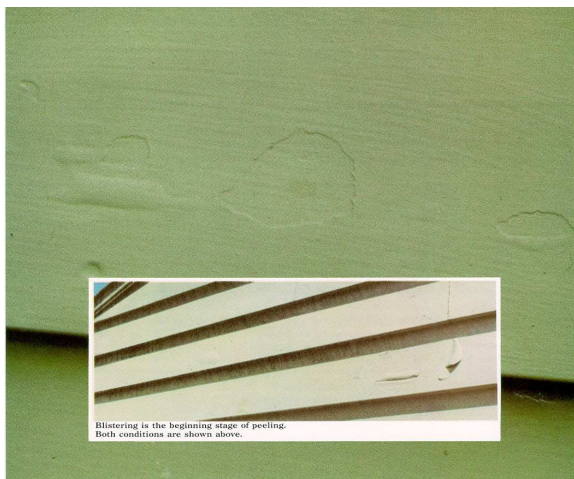
b. Blistering Paint. Blistering is the formation of bubbles in the paint film caused by either heat or moisture. To determine the cause, break open one of the bubbles; if bare substrate shows, the likely cause is moisture. However, if another layer of paint shows instead of substrate, heat probably caused the blister.

Blistering paint is deteriorated paint and must be repaired.

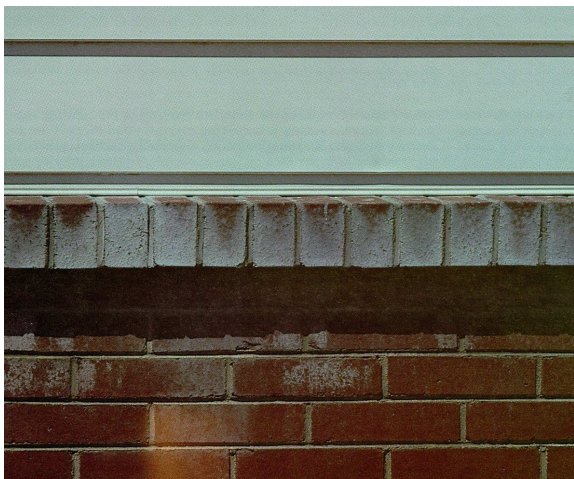
c. Chalking Paint. Chalking is the formation of a fine lead powder on the surface of a paint film. Almost all exterior oil paints are designed to eventually chalk in order to wash dirt away in the rain and provide a good surface for repainting. However, the chalking can also appear on the surfaces below the paint or on the ground. This chalking is usually caused by a failure to adequately prime or seal a porous surface, overthinning of paint, or exposure to sunlight.

Chalking paint is deteriorated paint and must be repaired.

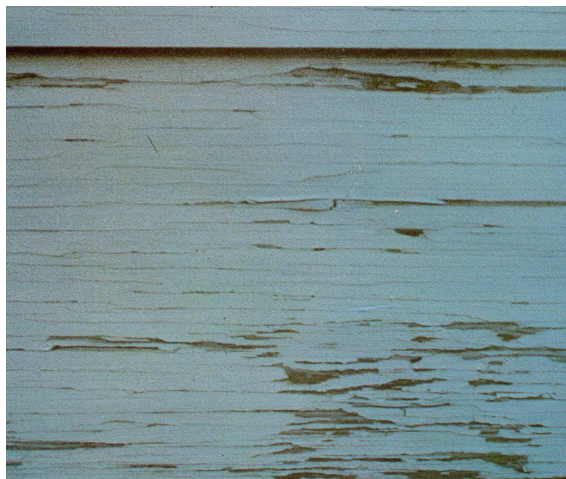
d. Checking Paint. Checking is a pattern of short, narrow breaks in the top layer of paint that is usually caused by a loss of elasticity. Plywood substrates can often cause checking.

Checking paint is deteriorated paint and must be repaired when an adhesion test determines that any layer is not securely bonded. To conduct an adhesion test, firmly press a 2" x 2" piece of masking tape to the suspect paint and rub the tape to adhere firmly. Lift up on one corner of the tape and remove the tape. If paint is evident on the tape, the paint is separating from the substrate or from underlying paint, and is not securely bonded.

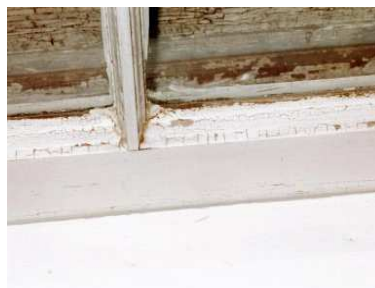
e. Chipping Paint. Paint chips are generally visible when chipping paint occurs. Chipping paint is paint that separates from the substrate due to either impact to the painted surface or poor surface preparation or paint failure.

Chipping paint is deteriorated paint and must be repaired.

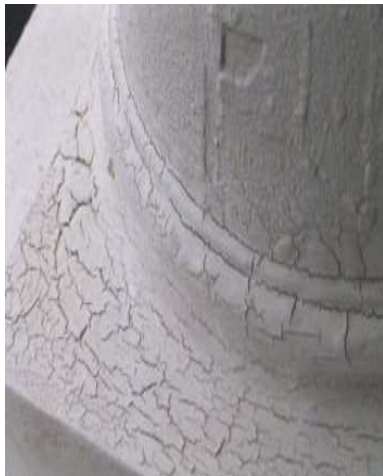
f. Cracking Paint. The cracks usually form parallel to the grain of the wood. Cracking paint is an advanced form of checking that usually occurs on surfaces with multiple layers of paint and includes breaks in the film that extend to the base substrate.

Cracking paint and cracked paint at a settlement crack is deteriorated paint and must be repaired when an adhesion test determines that any layer of paint is not securely bonded. To conduct an adhesion test, firmly press a 2" x 2" piece of masking tape to the suspect paint and rub the tape to adhere firmly. Lift up on one corner of the tape and remove the tape. If paint is evident on the tape, the paint is separating from the substrate or from underlying paint, and is not securely bonded.

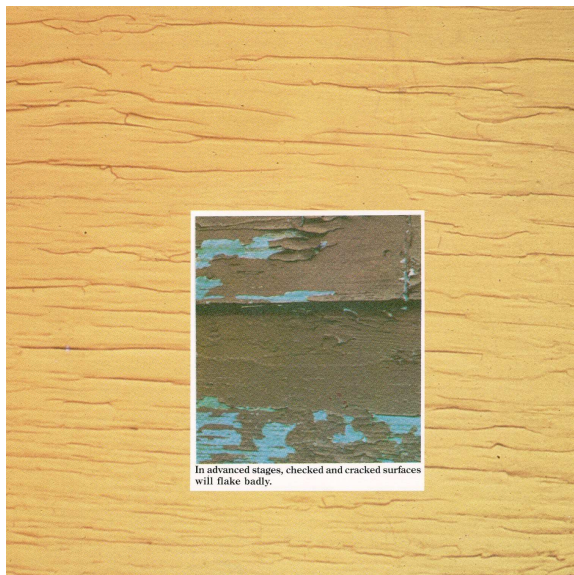
g. Flaking or Scaling Paint. Flaking is a form of paint separation often found in those exterior areas of the building susceptible to condensation, such as under the eaves. Salt deposits drawn to the paint film surface can cause scaling.

Flaking or scaling paint is deteriorated paint and must be repaired.
