## Chapter DHS 163

### APPENDIX G

#### Conducting a Visual Inspection

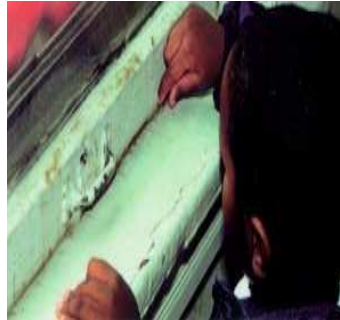
b. Mildew. A potential hazard is the formation of microbial growth on a painted surface. It is usually caused by excessive moisture. Mildew should be removed as a preventive measure to decrease the chance of paint film deterioration.

Paint affected by the mildew is deteriorated paint and must be repaired when an adhesion test determines that any layer is not securely bonded. To conduct an adhesion test, firmly press a 2" x 2" piece of masking tape to the suspect paint and rub the tape to adhere firmly. Lift up on one corner of the tape and remove the tape. If paint is evident on the tape, the paint is separating from the substrate or from underlying paint, and is not securely bonded.

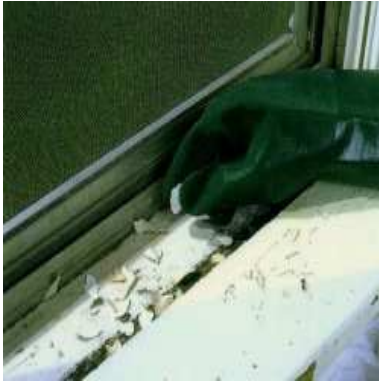
d. Paint Chips and Other Paint Debris. The presence of paint chips and debris that have not been proven to be lead-free are considered a hazard. They are evidence that paint is either deteriorated or subject to friction or impact. Visually inspect the floor, stairs, window wells/troughs and sills, and dripline for the presence of paint chips or other paint debris.

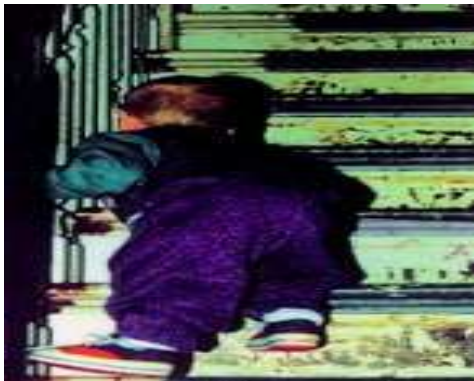
e. Painted Friction or Impact Surface. The friction and impact surfaces are evidenced by worn or chipped paint. The friction and impact of these surfaces can also result in dust-lead, which is not detected in a visual inspection.

Worn paint is often due to improperly hung doors, sticky window sashes, sticky drawers, etc. A source of dust-lead are windows that do not operate smoothly and doors that bind or otherwise contact the frame. To test for friction surfaces open and close painted doors, drawers and windows. Visually inspect doors, windows, trim, floors and stairs for evidence that the paint is worn or chipped.

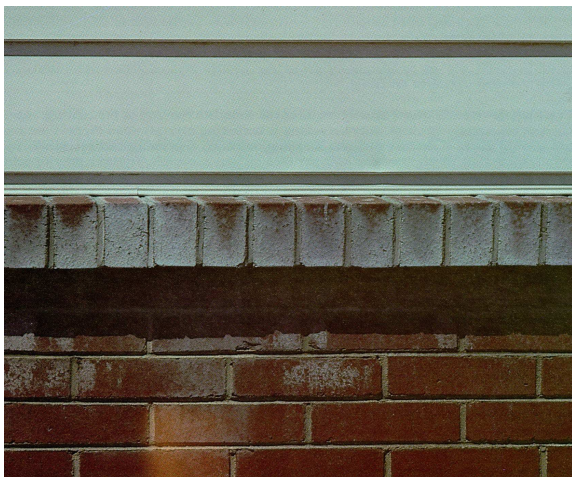
c. Chalking Paint. Chalking is the formation of a fine lead powder on the surface of a paint film. Almost all exterior oil paints are designed to eventually chalk in order to wash dirt away in the rain and provide a good surface for repainting. However, the chalking can also appear on the surfaces below the paint or on the ground. This chalking is usually caused by a failure to adequately prime or seal a porous surface, overthinning of paint, or exposure to sunlight.

Chalking paint is deteriorated paint and must be repaired.

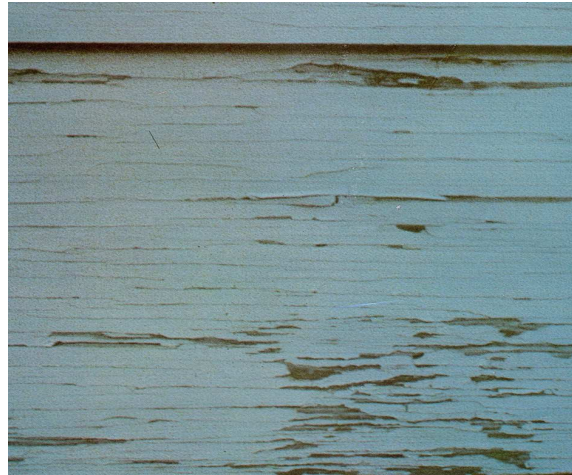
d. Checking Paint. Checking is a pattern of short, narrow breaks in the top layer of paint that is usually caused by a loss of elasticity. Plywood substrates can often cause checking.

Checking paint is deteriorated paint and must be repaired when an adhesion test determines that any layer is not securely bonded. To conduct an adhesion test, firmly press a 2" x 2" piece of masking tape to the suspect paint and rub the tape to adhere firmly. Lift up on one corner of the tape and remove the tape. If paint is evident on the tape, the paint is separating from the substrate or from underlying paint, and is not securely bonded.

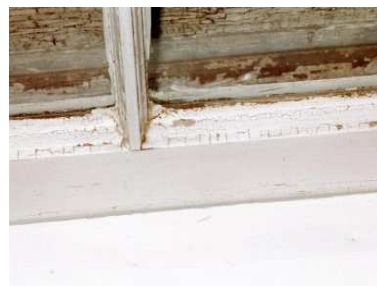
e. Chipping Paint. Paint chips are generally visible when chipping paint occurs. Chipping paint is paint that separates from the substrate due to either impact to the painted surface or poor surface preparation or paint failure.

Chipping paint is deteriorated paint and must be repaired.
