Chapter DHS 163

APPENDIX G

Conducting a Visual Inspection

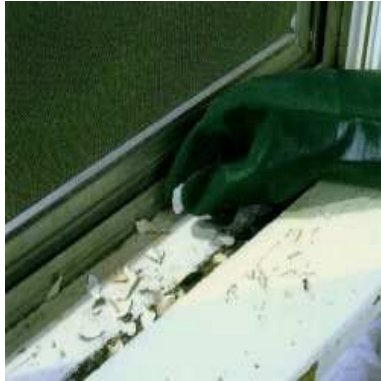
d. **Paint Chips and Other Paint Debris.** The presence of paint chips and debris that have not been proven to be lead-free are considered a hazard. They are evidence that paint is either deteriorated or subject to friction or impact. Visually inspect the floor, stairs, window wells/troughs and sills, and dripline for the presence of paint chips or other paint debris.

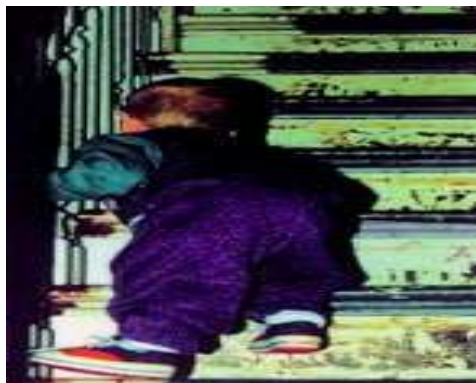
e. **Painted Friction or Impact Surface.** The friction and impact surfaces are evidenced by worn or chipped paint. The friction and impact of these surfaces can also result in dust-lead, which is not detected in a visual inspection.

Worn paint is often due to improperly hung doors, sticky window sashes, sticky drawers, etc. A source of dust-lead are windows that do not operate smoothly and doors that bind or otherwise contact the frame. To test for friction surfaces open and close painted doors, drawers and windows. Visually inspect doors, windows, trim, floors and stairs for evidence that the paint is worn or chipped.
